Consolidated Carpet – Floor Prep Site

The NYU Anesthesiology project had several unique challenges that required special applications through each phase from floor prep to completion. The space itself resides between two buildings, with open areas where the two floor slabs meet one another. Because of this, there is an uneven gap found throughout the space, where a level floor is necessary.

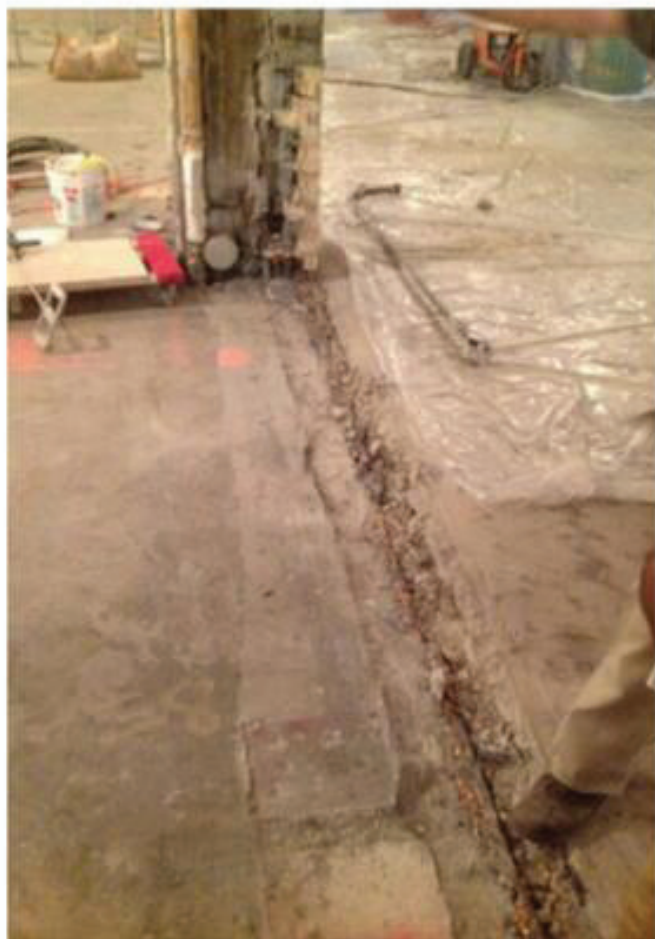
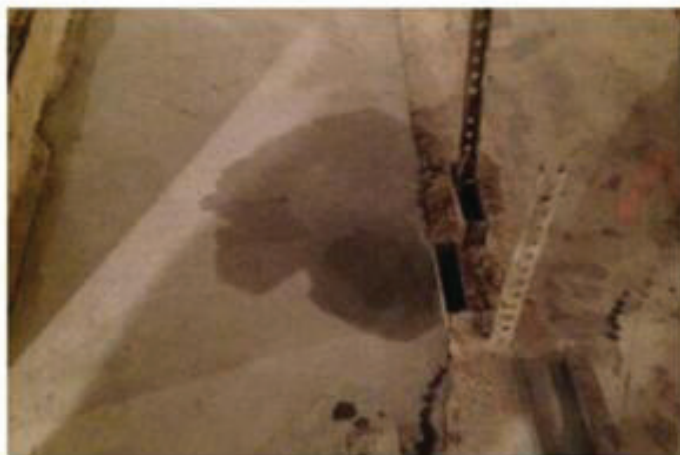
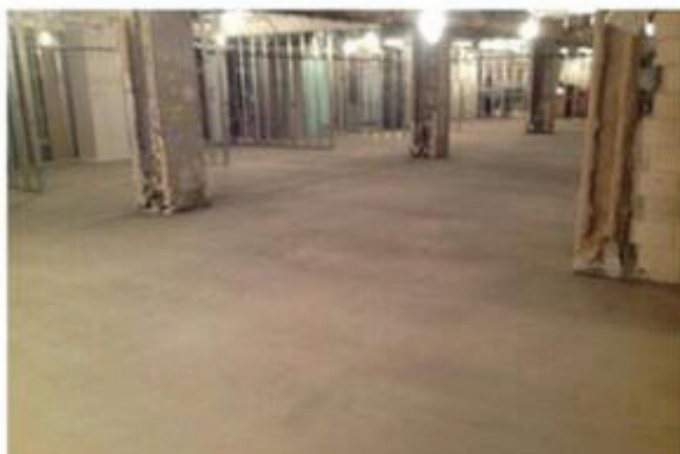
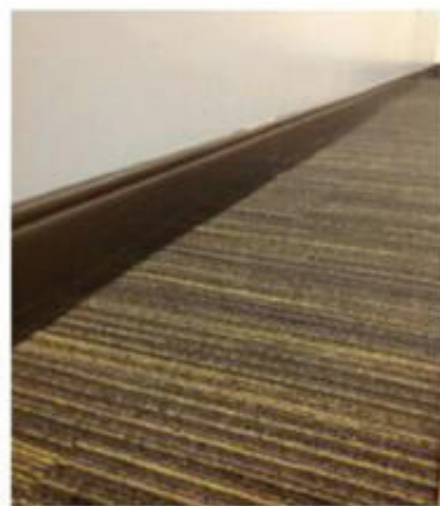
In some areas, the two slabs are off by up to half an inch to an inch. Due to the wear and tear within the space over years of usage, there were many holes and trenches that existed in the floor that also had to be covered up. Consolidated Carpet's goal was to create a smooth surface to properly install

CLOCKWISE FROM TOP: This photo shows where the two slabs of the buildings come together; The site had many holes and trenches in the floor from previous construction – creating a challenging environment to have level flooring throughout the space; The first phase of the pour started in June 2013, after the base walls were installed; Once the pour was completed to ensure a level space, carpet and rubber were installed.

After the base walls were installed, Consolidated began with floor prep. It's important to note that the decision to wait for the walls to be put up was made to help keep costs down, as well as create level floors in each separate room – rather than the entire floor all at once. Deeper base walls were also used to ensure that the pour did not seep into the walls or adjoining rooms. Consolidated used CMP products to level the floor with an average of 5/8", which totaled 10,000 square feet. ■
